Aviation Investigation Preliminary Report

Location:	Hampton, VA	Accident Number:	ERA25FA185
Date & Time:	April 24, 2025, 11:35 Local	Registration:	N530RH
Aircraft:	MX AIRCRAFT TECH PTY LTD MXS	Injuries:	1 Fatal
Flight Conducted Under:	Part 91: General aviation - Personal

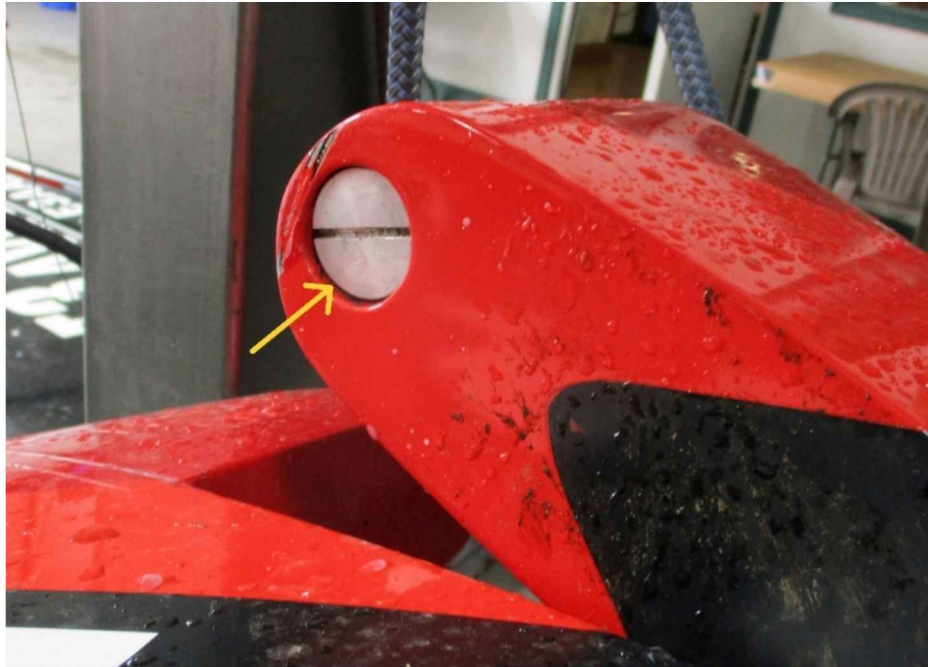
Figure 1. Counterweight plug as installed on the right elevator (postaccident photograph).

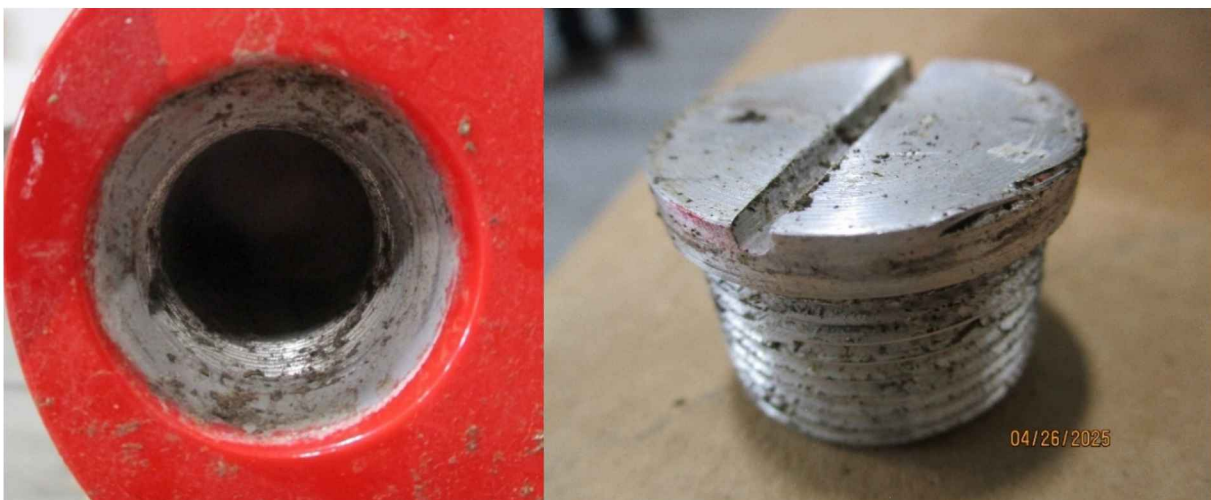
The airplane came to rest on a heading of 150° in a grass ditch about 100 ft from the left side of runway 08 and 500 ft beyond the approach threshold. All major components of the airplane were accounted for at the accident site. The left elevator counterweight plug was not installed and was located about 10 ft behind the wreckage in the grass. Dirt consistent with that found in the vicinity of the accident site was identified on the elevator, as well as in the counterbore and threaded area where the counterweight plug would have been installed. The counterweight plug threads were intact and also contained similar dirt contamination consistent with that found on the elevator. Additionally, about half of the circumference of the left elevator counterweight plug displayed gouging and there was evidence of paint transfer (figure 2).

Figure 2. Left elevator counterweight installation hole (left) and recovered counterweight plug (right). Note: gouging and paint transfer on counterweight plug.

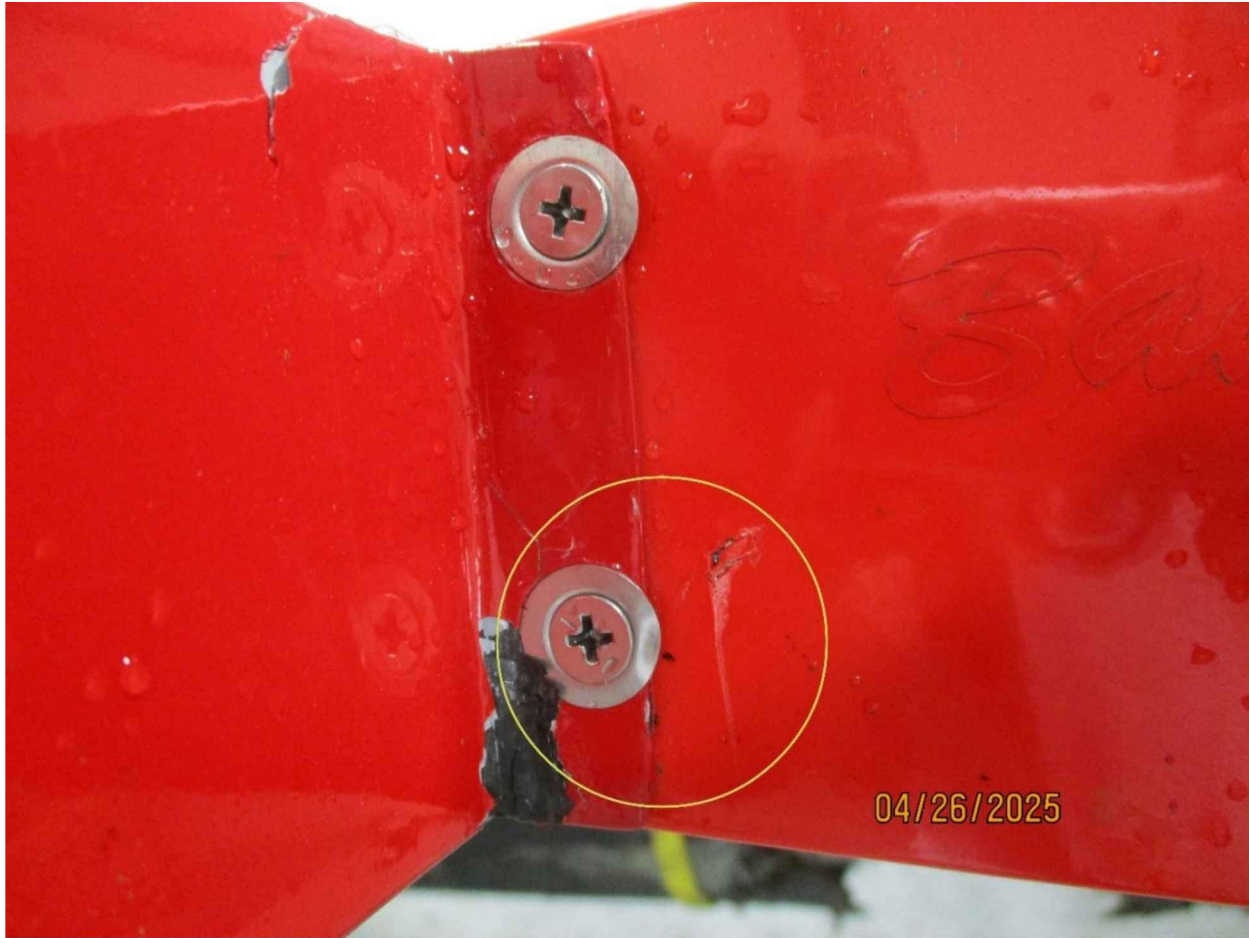
The horizontal stabilizer structure adjacent to the elevator position where the counterweight plug would have been installed displayed dents and paint scrapes consistent with contact with the counterweight plug (figure 3).

Figure 3. Horizontal stabilizer structure adjacent to the left elevator counterweight plug. Note: dented washer and scrapes, circled in yellow.
